ECR/ECO NUMBER WC2262 --- SERVICE INFORMATION --- PRINTED 12.11.92

SUBJECT Use 8375 instead of 8372 AGNUS requires rework.

MODEL A2000

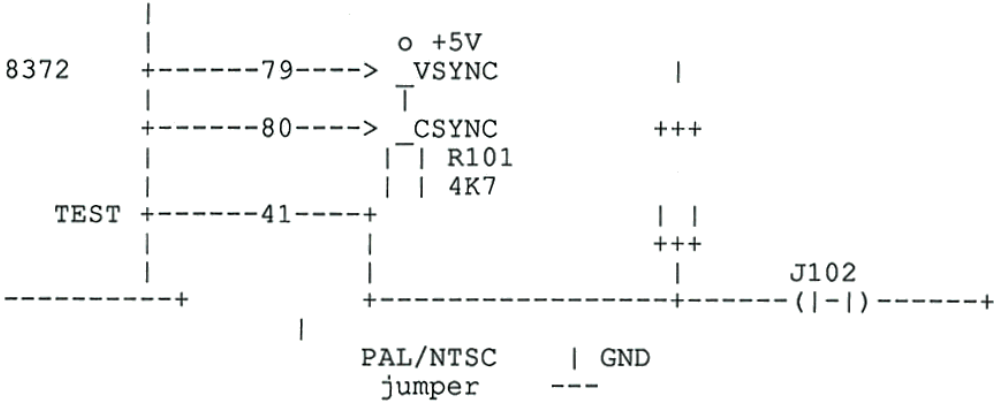
This is the 'normal' setup (Schematic 312721):

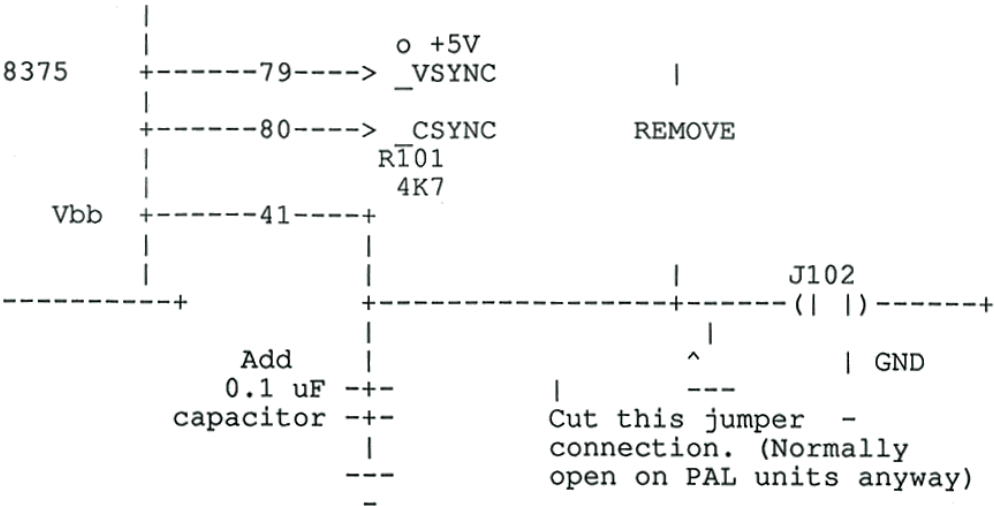
This is the new setup (with 318069-16/17):

ISSUE 318069-029 AGNUS has been replaced by 318069-16 (PAL) and 318069-17 (NTSC). These versions have Vbb connected to what was the NTSC/PAL pin of the -029.

PIN 41 has a new meaning and the rework mentioned above must be implemented to make the 318069-16/17 work in old boards.

ACTION A 0.1 capacitor uF must be added between this pin (41) and ground.  
Also the R101 (4k7 ohms) must be removed and J102 cut open.
